## SNOWPLOW BLADES

Rémincourt • Belgium

### Case-story

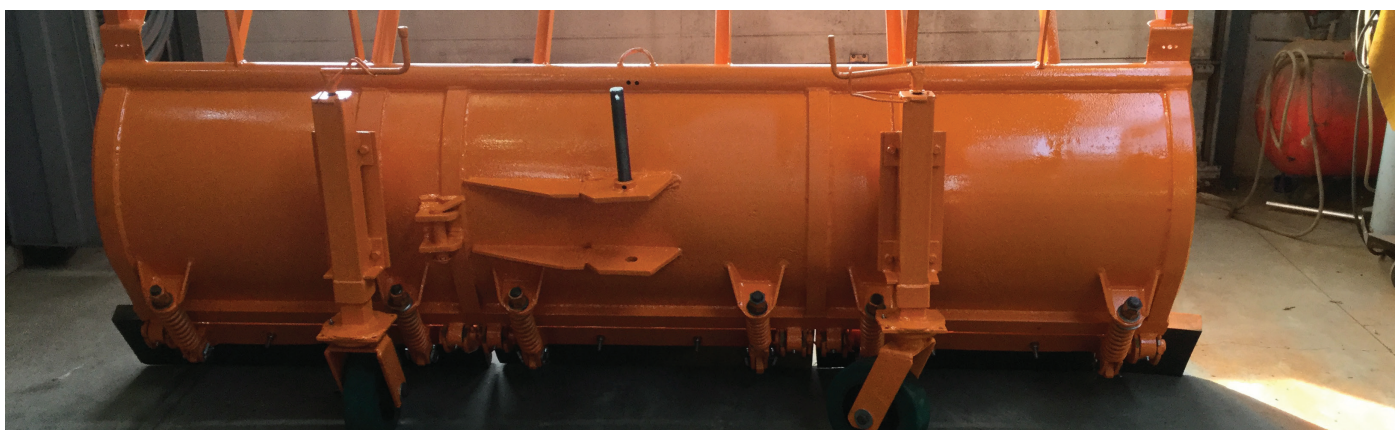
Snowplow blades from the Rémincourt municipal administration for a 'second life', requiring a paint system that is highly resistant to salty moisture.

Application of **Polyzinc** on the same day.  
After transport to the end customer:

- 1 layer of **Polyguard** applied by spray gun and diluted with 10% **Solvatane** (2 wet-in-wet passes).
- 2 layers **Mixtane Spray** gloss RAL 2008.
- After reassembling the lower rubber strips, a light mist layer of **Mixtane** to repair damage caused by tightening various nuts and bolts.
